TREE RISK ASSESSMENT

SITE ADDRESS: Lillooet Ave.
Harrison Hot Springs

2024-07-16

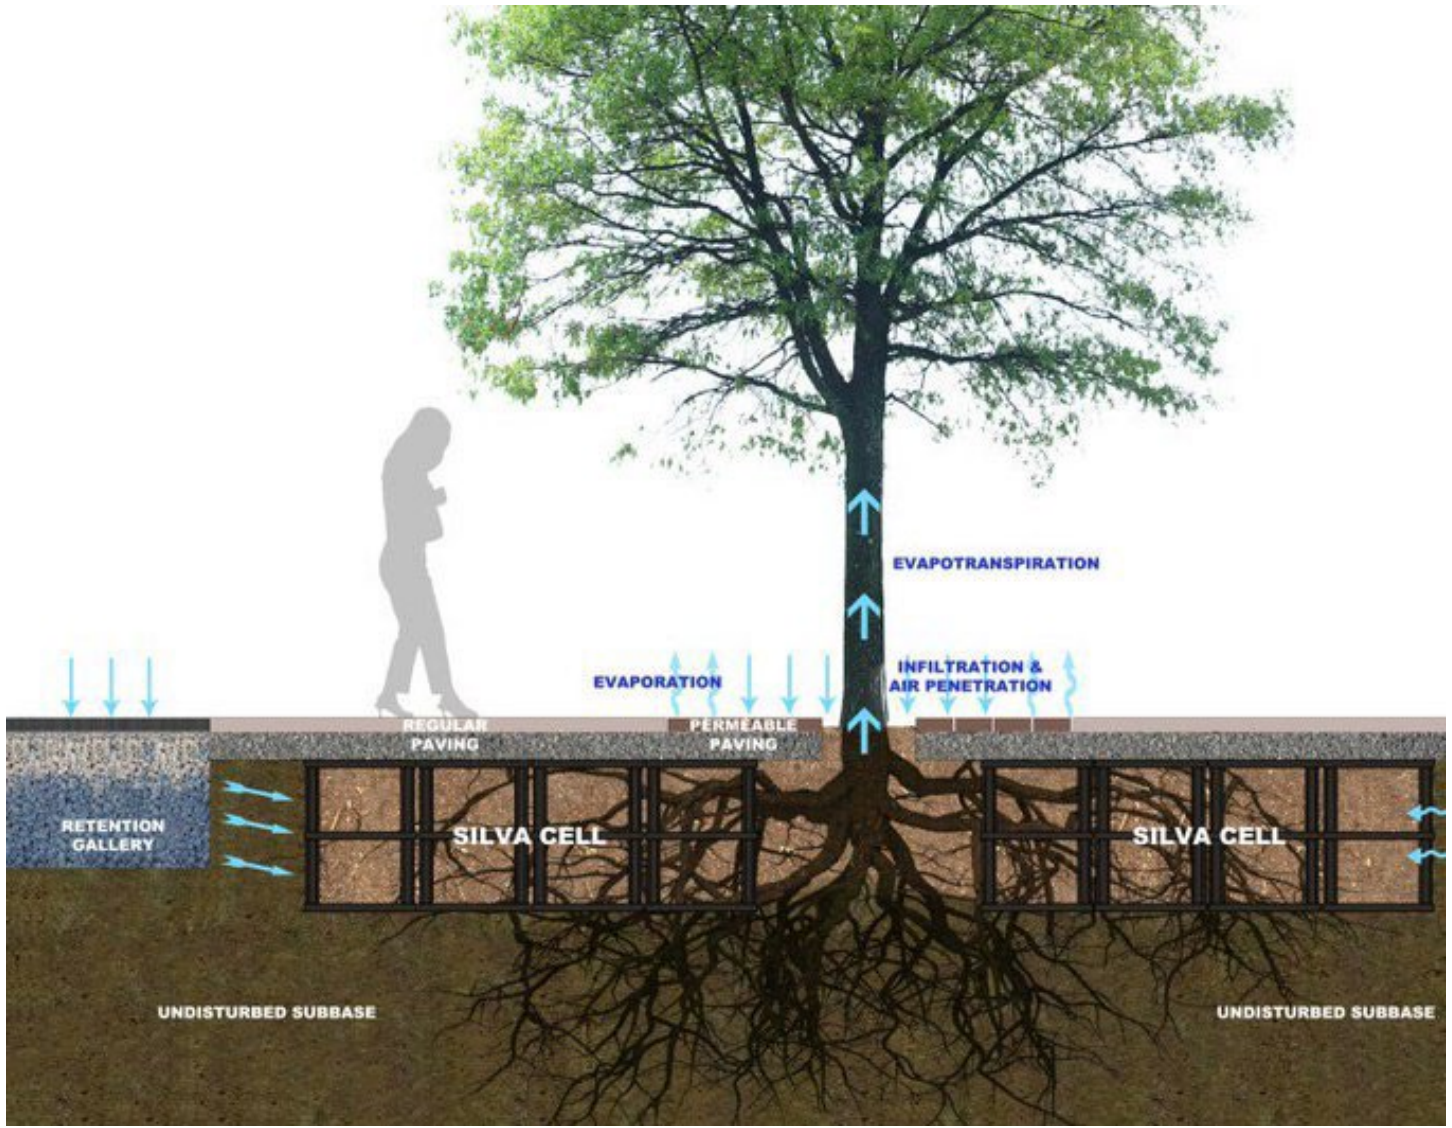
Fig.1 Silva Cell soil vault system, image sourced from www.deeroot.com. Recommended infrastructure around replacement trees.

- It is recommended that trees numbered 290,301, 407 and 427 are removed prior to Winter of 2024.
- Replacement trees should be replanted after fill is removed and soil amended. Recommended replacement species include *Gingko bilboa*, *Carpinus sp.* and *Acer macrophyllum*. To provide soil volume beyond the boulevard I encourage the village to research silva cells and other soil vaults to allow adequate soil volume extensions beneath the adjacent roadways and driveway letdowns. Trees should be planted following CLA specifications.

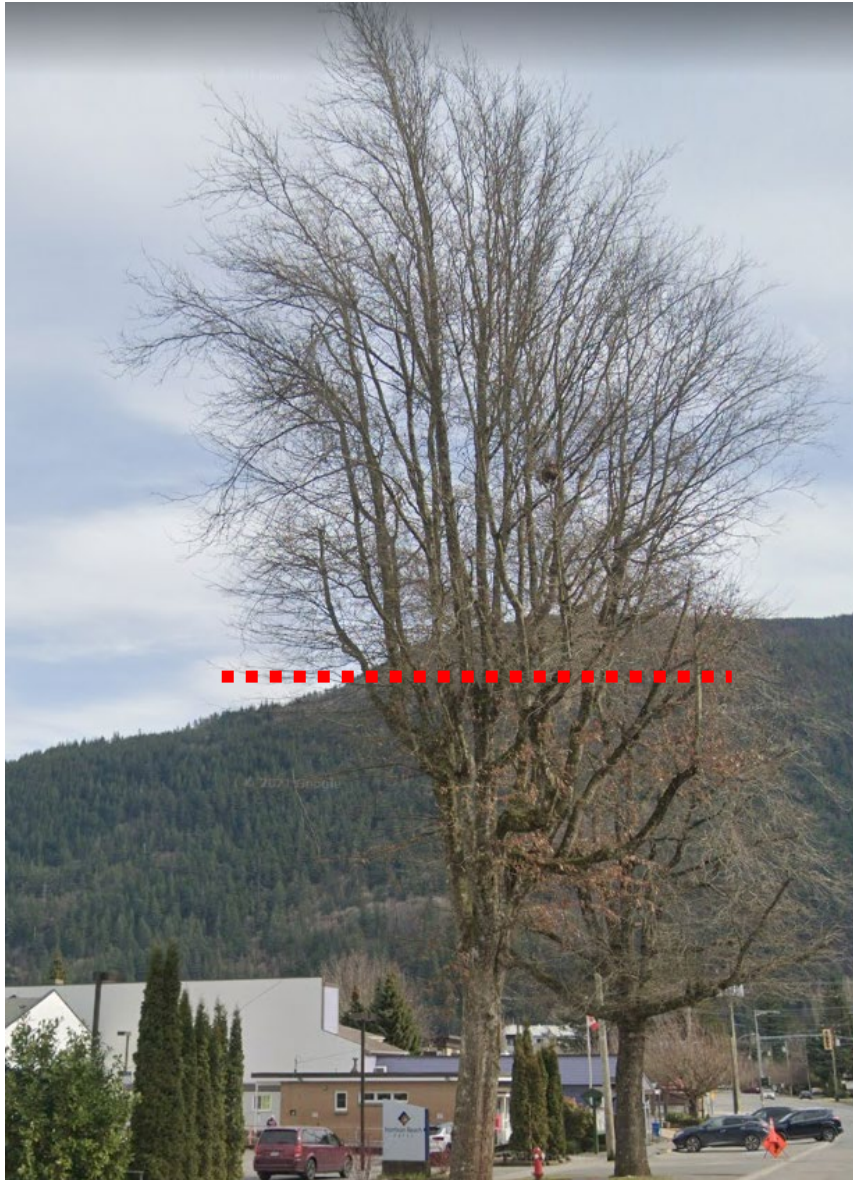
Fig. 2 –Tree 407, previous point of topping at red line

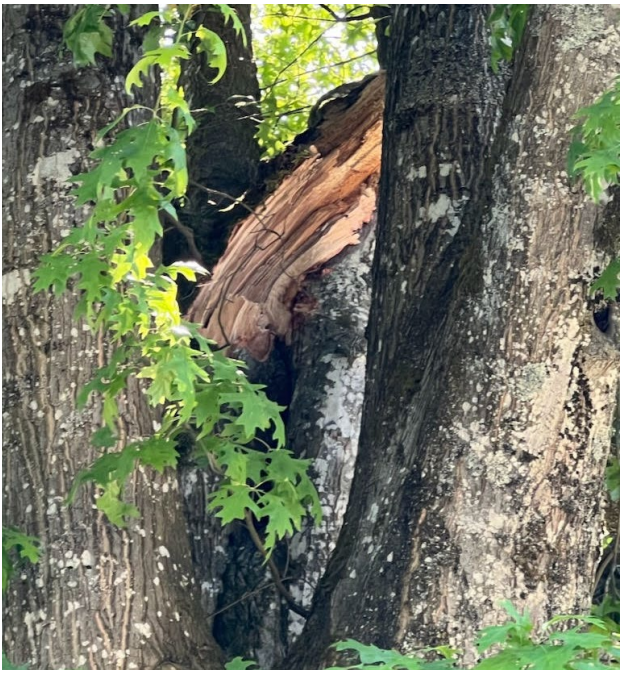
Fig. 3 – Tree 429 past branch failure.

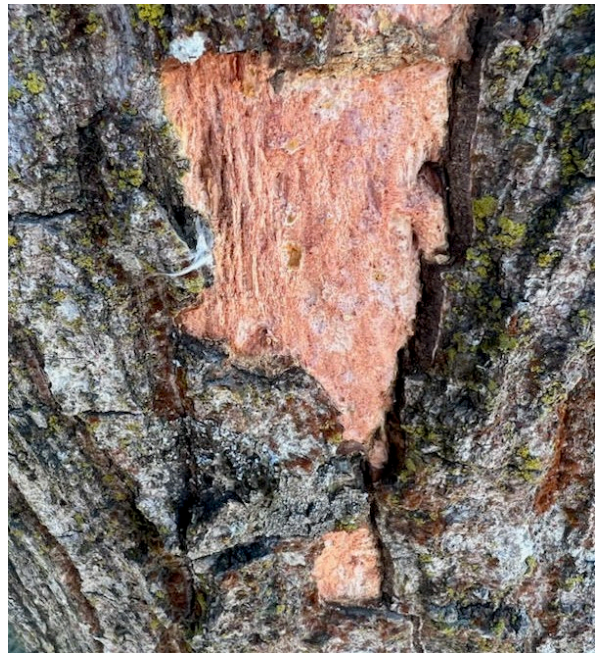
It was observed in July 2023, that two trees had recently suffered random branch failure several feet above the point of previous topping. Each branch was significant in size and did not break at a union but several feet above. Both wounds exhibited spongy bark in phloem and cambium layers, and with a whitish appearance – consistent with rot pathogens such as *Armillaria sp.* Throughout all crowns indicators of rot were present, such as cavities, poor response growth at large pruning cuts, a single canker was observed several feet up the trunk of a single tree. At that time the phloem (inner bark) appeared spongy, showing loss of lignin. This was discovered through random trunk sampling by means of tissue extraction.

Fig.4 –Phloem showing spongy tissue and small lesions.

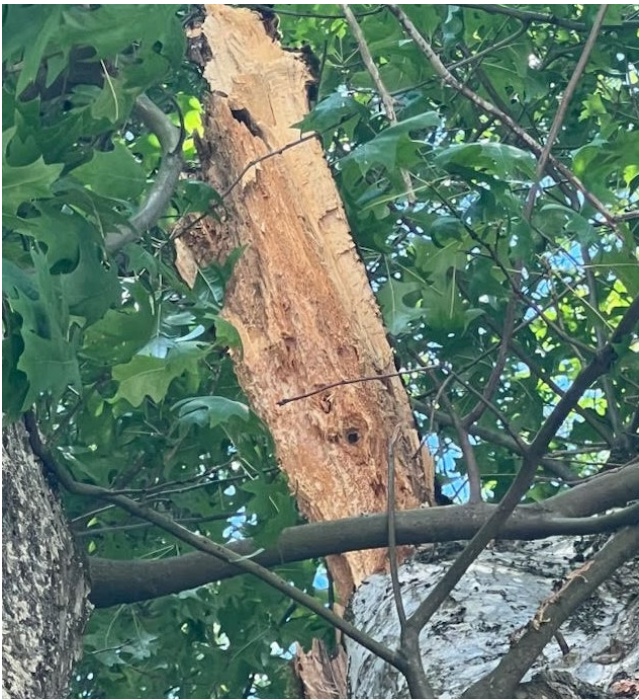
Fig.5 – Recent branch failure, tree 407.

TAG #	COMMON NAME <i>BOTANICAL NAME</i>	TRAQ RISK RATING	DBH (CM)	C-RAD (M)	LCR (%)	COMMENTS	PRESCRIPTION
407	Red Oak <i>Quercus rubra</i>	High (Branch failure + decline)	92	6.75	60	<ul style="list-style-type: none"> Recent (within 1 week) branch failure, scaffold branch 30cm diameter. Wound wood is spongy. Root flare buried, small mechanical wound at grade with poor response growth. Various poorly healed wounds, drilled into wound on East side of trunk 1m from grade, little resistance and shavings indicate presence of decayed wood up to 4" at site of drilling. Small reddish-brown lesions observed on NE trunk from grade to 2m. Bark easily removed in 10 cm² patch at site of lesion. Inner bark / phloem is spongy. Sapwood appears healthy. Chlorotic and stunted leaf crop. 	<u>Remove</u>

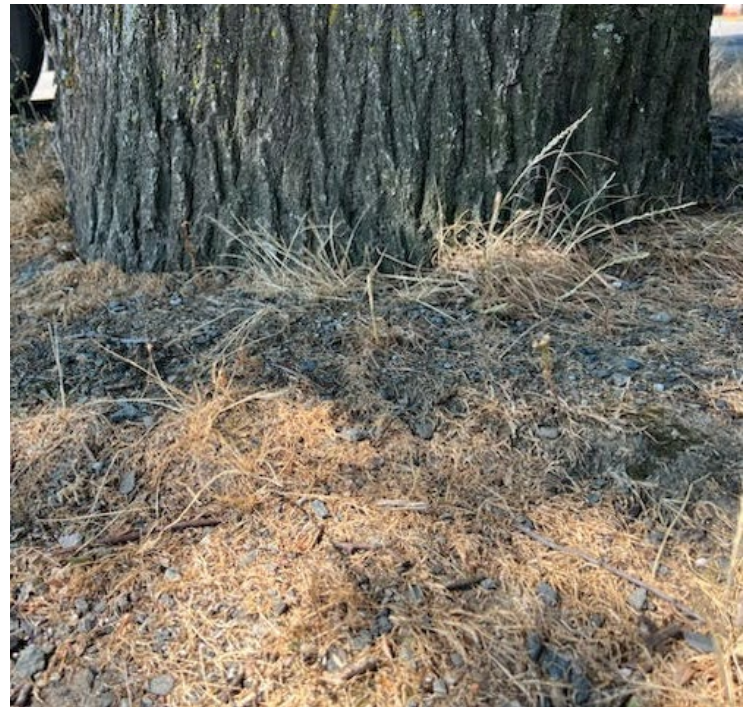
All trees continue to grow within limiting environments; soil compaction, lack of irrigation, lack of available soil volume and mechanical injury have presented challenges to their root systems. All root flares were and continued to be buried by heavy fill and gravel. Soil substrate beneath initial compacted layers is a sandy loam and leads to further challenges in providing available water.

Fig.6 – Example of root flare buried on all trees.

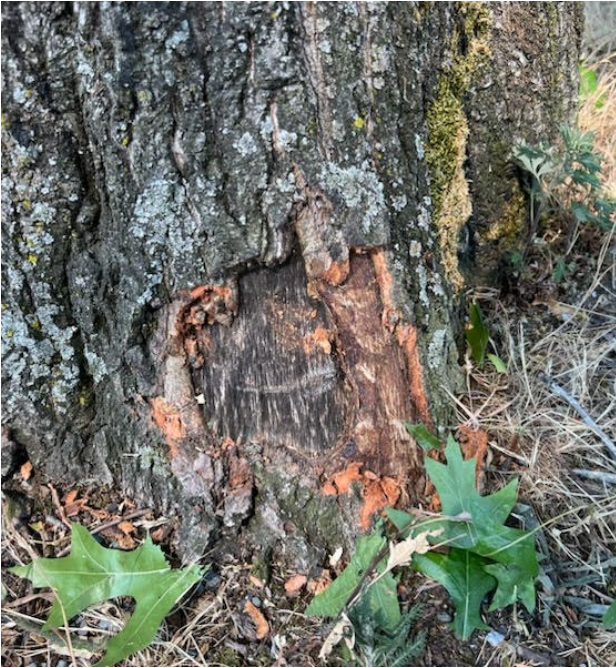
Invasive pruning and mechanical wounds along the lower trunk provided entry points for fungal pathogens to thrive, the trees concurrently face environmental stress from soil compaction and root asphyxiation.

Fig. 7 – Tree 407 mechanical wound lower trunk

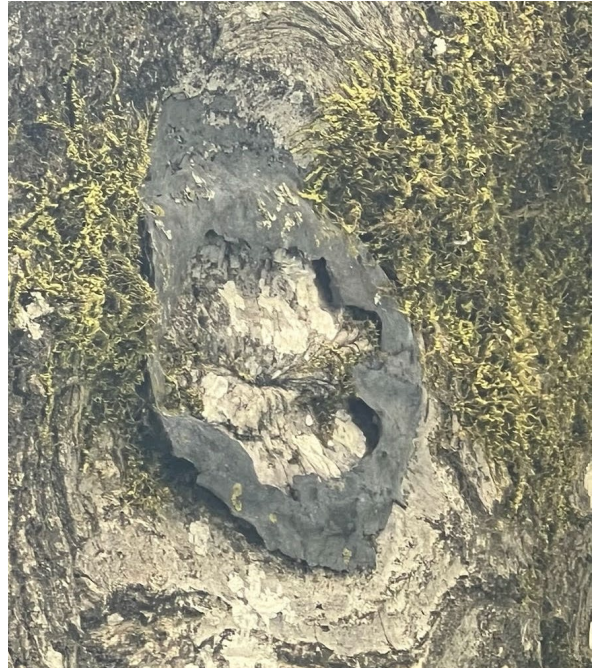
Fig.8 – Canker at branch wound in upper canopy.

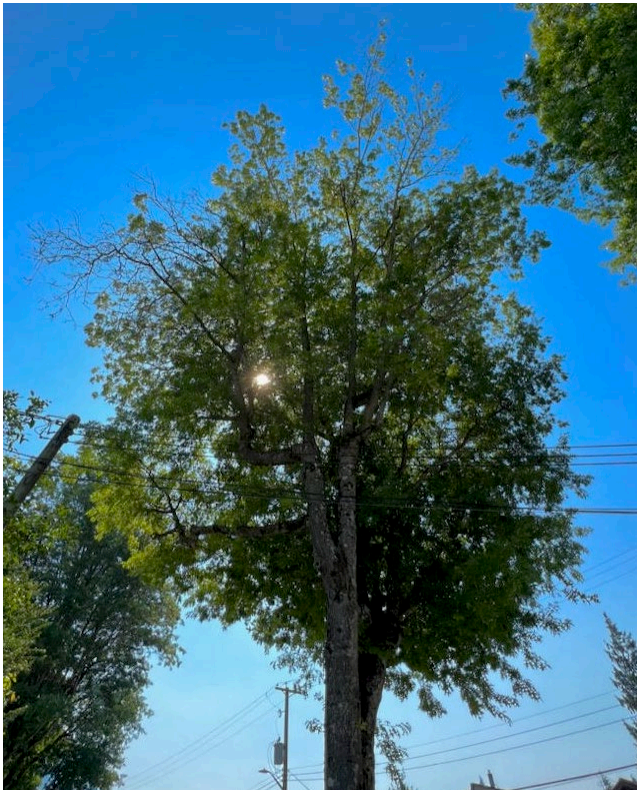
Fig .9 – Tree 301 thinning canopy

TAG #	COMMON NAME <i>BOTANICAL NAME</i>	TRAQ RISK RATING	DBH (CM)	C-RAD (M)	LCR (%)	COMMENTS	PRESCRIPTION
301	Red Oak <i>Quercus rubra</i>	High (Branch failure + terminal decline)	75	5.0	60	<ul style="list-style-type: none"> • Codominant main branch union • Crown dieback, thinning upper canopy North side. • End of scaffold branch at previous pruning cut – hollow (NW side above service line) • Various dead branches over 5cm diameter laying on ground. Recent large branch failure onto road. • Core sample taken, showing spongy decay throughout 12" core. 	<u>Remove</u>
290	Red Oak <i>Quercus rubra</i>	Medium (Branch Failure + decline)	63	4.5	60	<ul style="list-style-type: none"> • Chlorotic leaf tissue, stunted crop. • Various Abiotic stressors. • Previously topped, poor response at wounds. • Codominant stems. 	<u>Remove</u>

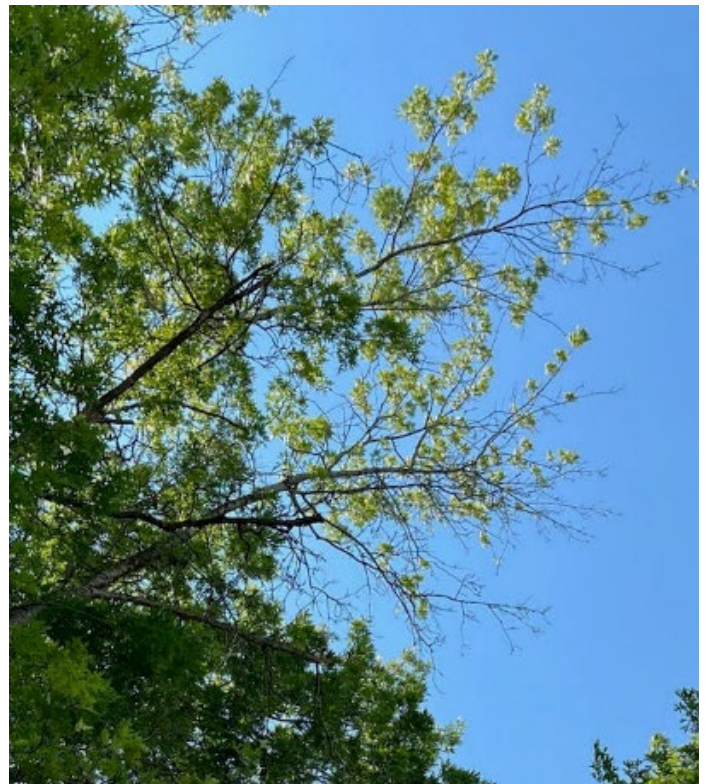
Fig. 10 - Example of thinning canopy

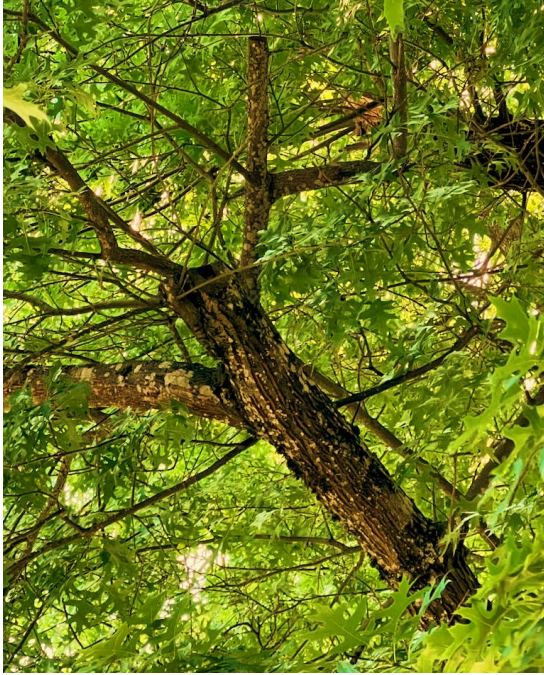
Fig .11 - Decay at pruning wound, tree 429.

TAG #	COMMON NAME <i>BOTANICAL NAME</i>	TRAQ RISK RATING	DBH (CM)	C-RAD (M)	LCR (%)	COMMENTS	PRESCRIPTION
429	Red Oak <i>Quercus rubra</i>	High (Branch failure + decline)	88	6.5	70	<ul style="list-style-type: none"> • Previous branch failure, scaffold branch appx. 20+ cm diameter. Wound wood appears spongy. • Root flare is buried with compacted fill and gravel. • Leaf tissue chlorotic, predominately south facing crop as well is stunted. • Previous pruning wounds have not adequately healed, canker present and various cavity throughout crown. 	<u>Remove</u>

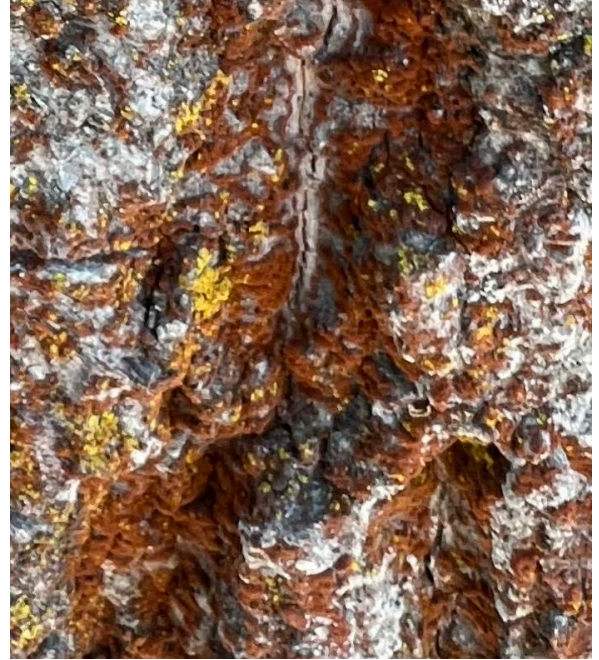
Fig. 12 - Trentepohlia Algae near spongy inner bark.

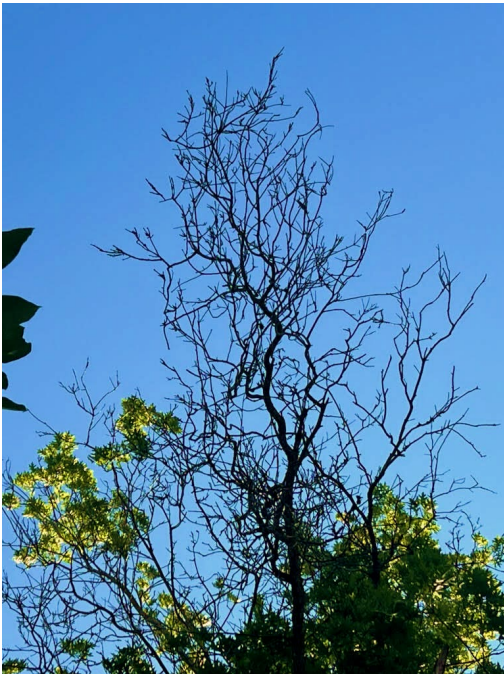
Tree #301 shows branch dieback advanced to affect 3 additional North scaffold limbs. A 12" core sample was taken from this tree and showed spongy tissue and decay extending from sapwood into heartwood.

Fig.13 - New crown dieback.

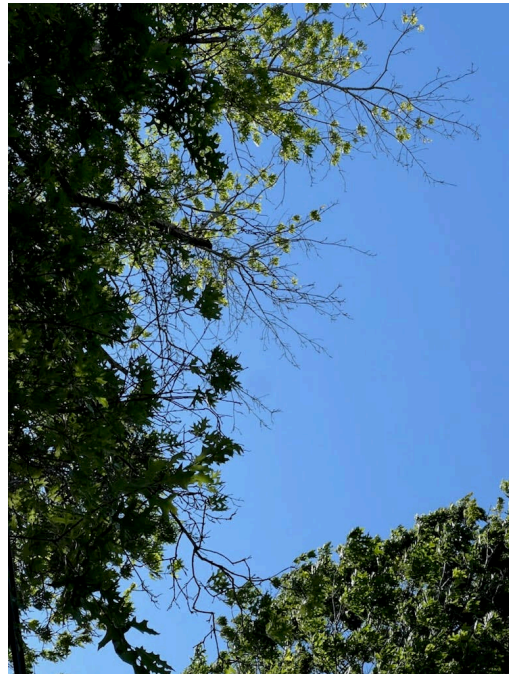
Fig.14 - Increase in crown dieback.

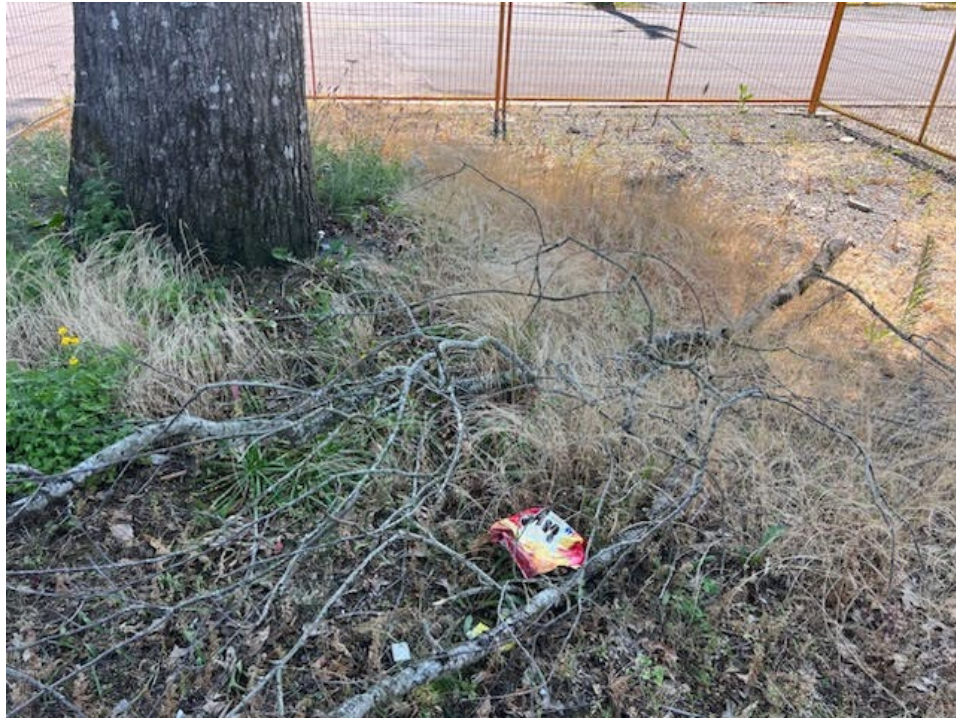
Branches 3-4" in diameter had fallen and remained onsite within the protection zone beneath tree #407. City staff had attended to a more severe branch failure beneath the trees, which were removed from the roadway earlier this summer.

Fig.15 – Branch failures. Recent branch failure over road, removed.

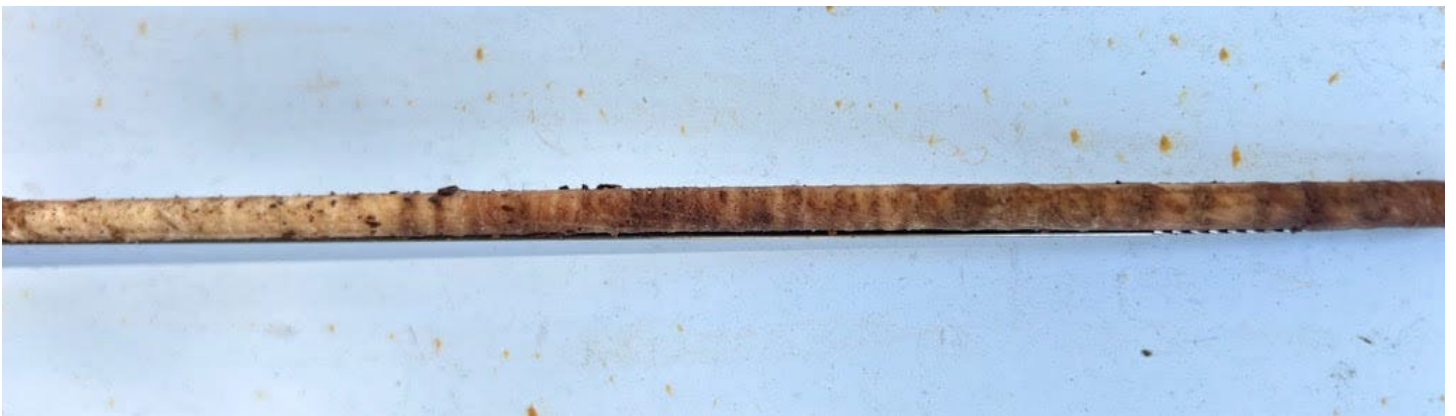
Further to this, significant dieback and branch failure has increased along with new information showing presence of white rot within internal tree layers.

Fig.16 – Spongy texture observed with indication of decay throughout core sample.
